## STUDY ON THE BEHAVIOR OF LOW-VOLTAGE CABLE INSULATION SUBJECTED TO THERMAL CYCLE TREATMENT

**Abstract.** *The paper presents a study on the effects of thermal aging on a low-voltage cable. Cable samples with a length of 50 cm were subjected to thermal cycling from +140 °C to -20 °C in a climate chamber with controlled temperature. This treatment compares the short-term failure or the emergency overload of some cables under real operating conditions at low temperatures. The effect of the temperature cycle is investigated through electrical measurements such as dielectric spectroscopy, voltage response measurements, and mechanical measurements such as Shore D hardness investigation. The results revealed that the thermal cycles of accelerated aging caused the plasticizer to diffuse into the jacket and then be released into the environment. At the same time, the thermal shocks produced microcracks in the cable jacket, accelerating the removal of the plasticizer.*

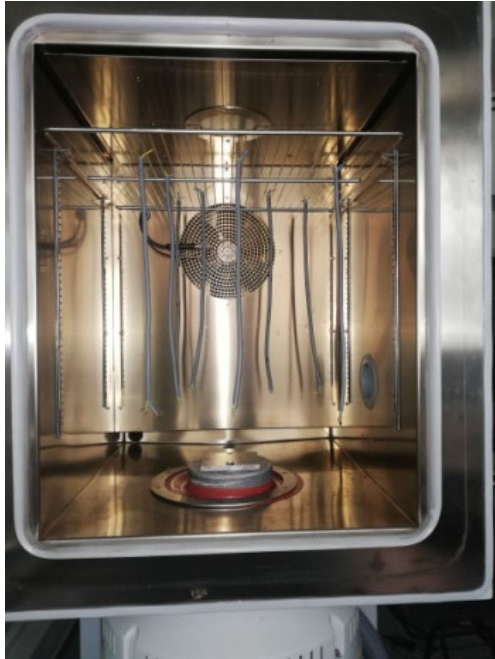
Figure 3. Arrangement of the samples in the climatic chamber CH 250 TVT.

The 50 cm long cable samples were placed in the climatic chamber in static air and uncontrolled humidity conditions.

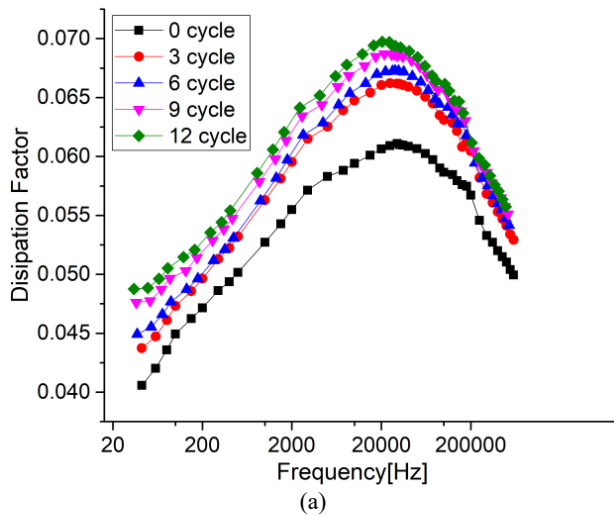
**Figure 9.** Variation of the dissipation factor measured on the studied frequency range, according to aging parameter: (a) 1 ÷ 12 cycles, (b) 15 ÷ 30 cycles.

Figure 9 shows the dissipation factor evolution as a function of frequency for the cable samples after a specific number of testing cycles.
